Project Title : Indicative Fire Test on 12 mm Thick Versafire
Fire Retardant Construction Board

Client : Euroform Products Ltd

Reference : P03157ASKR

An indicative fire test was performed on 12 mm thick Versafire Fire Retardant Construction Board built onto a vertical surround comprising refractory brick and block work and held in position using a calcium silicate board beading system. The test was conducted at CERAM using the reduced scale furnace with the specimen tested to the general principles of BS 476 part 20: 1987.

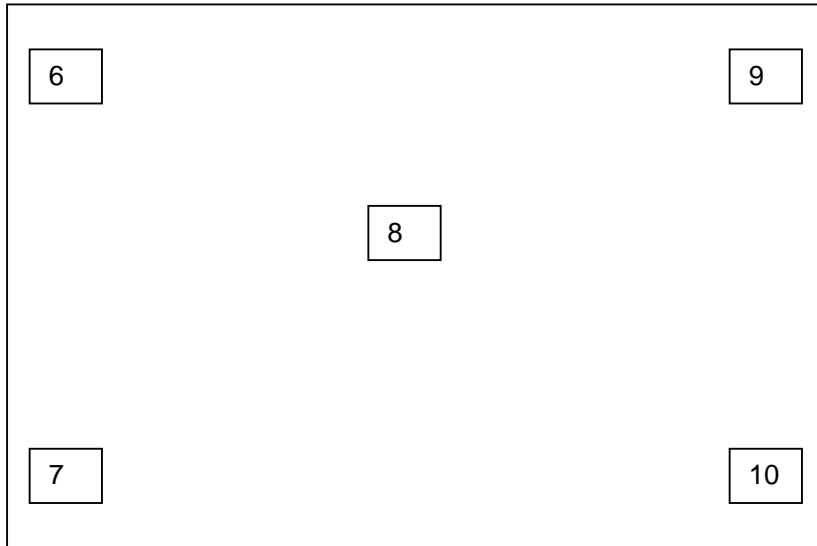
Figure 1 - Sketch of Thermocouple Locations

The numbers relate to the thermocouple details given in the test data section. Sketch is not to scale.

Figure 1 – APPENDIX Section shows a sketch of the panel NON-FIRE side with positions for specimen thermocouples

Specimen surface temperature (non fire side) was measured using five type K thermocouples as specified in BS 476 Part 20: 1987 section 6.4.2.1. Four thermocouples were positioned on the board face, approximately 50 mm from the panel corners and the bead joints. A fifth thermocouple was located on the centre of the panel face. Thermocouple location details are shown on the specimen sketch Figure 1 in the APPENDIX.

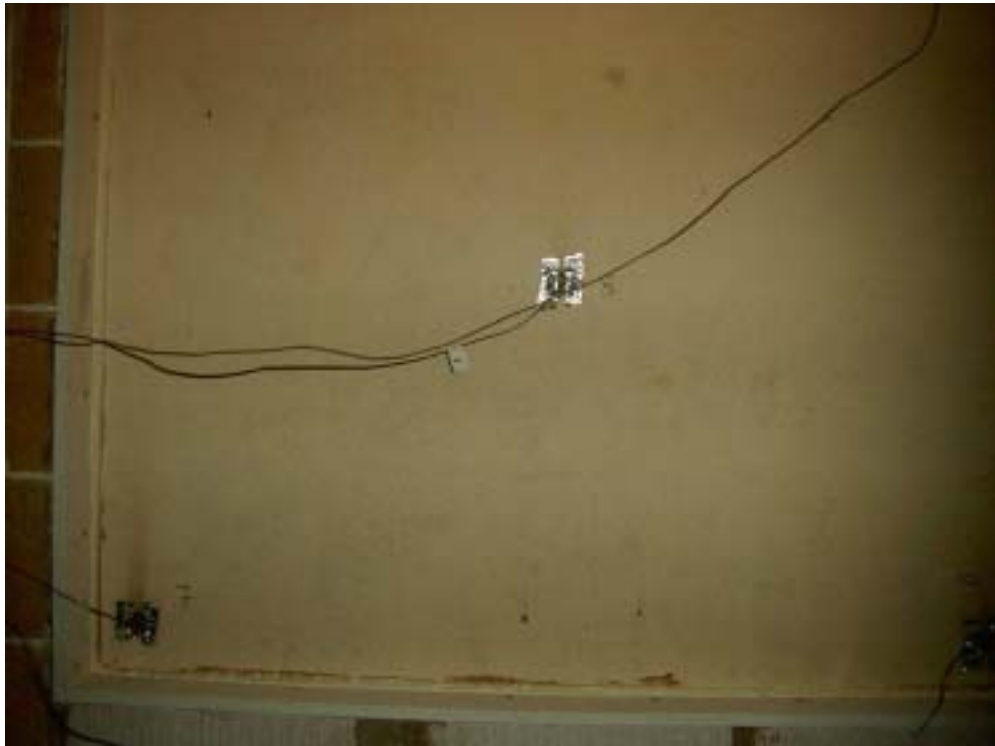
Figure 4 – Observation at 25 Minutes

23:40	U	7.4 - 8.6	Smoke exiting panel adjacent to all thermocouple locations.
25	U	8.5-8.9	Development of horizontal line mark on panel face circa 100 mm from C-D joint – Figure 2.
26	E	8.5-8.9	Panel discolouration has cleared, random cracks still evident combined with flaky appearance.
28	U+E	8.5-8.9	Smoke receded, both U + E faces appear stable.

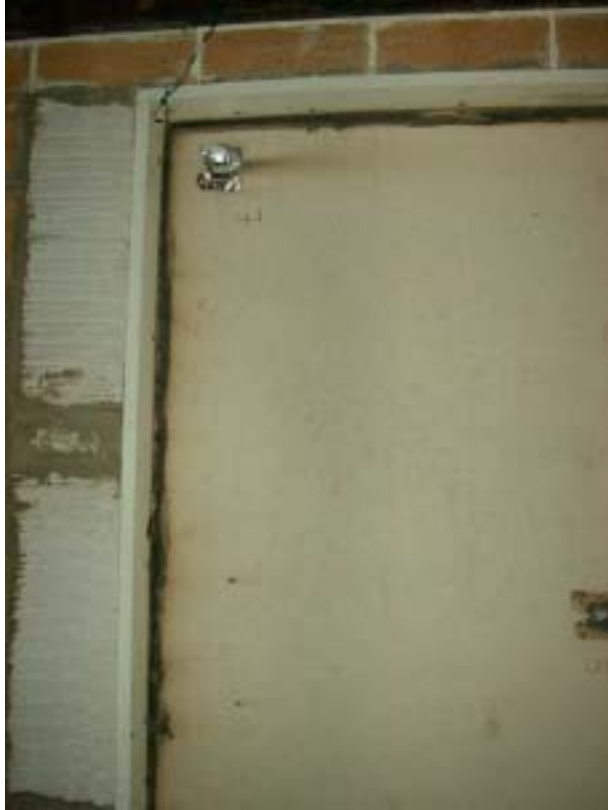
Figure 5 – Observation at 53 Minutes

28:30	U	7.7-9.3	All bead/panel intumescent joints now discoloured.
34:54	U	7.7-9.3	TC 6 fallen away from panel surface.
36	U	7.7-9.3	TC 7 fallen away from panel surface.
43	U	6.9-9.3	TC 8 and 10 not in contact with panel surface.
53-55	U	7.8-9.1	Figures 3 and 4 – TC 9 not in contact with panel surface.
55-100	U+E	7.6-8.7	No change
105	U	7.5-8.9	As above, Figures 5 and 6.
106	U	7.7-9	A-B bead bowing.
112	U	7.5-9.2	A-B bead bowing, two fixing pins fallen out.
116	U	8.1-9.4	Panel bowing into furnace with bow at maximum at panel centre point, bow circa 50 mm.
118	U	8.1-9	All bead/panel joints cracked.
119	U	8.3-8.5	Figure 7.
120	U	8.6-9.1	A-B bead cracked.
136	U	8.1-9.6	As above, crack opened.
145	U	8.5-9	Figure 8 showing bead joint open.
153	U	7.9-8.5	A-B bead partially separated.
154	U	7.9-8.6	Cotton pad ignited at open joint, integrity failure. Panel showing no signs of integrity damage.

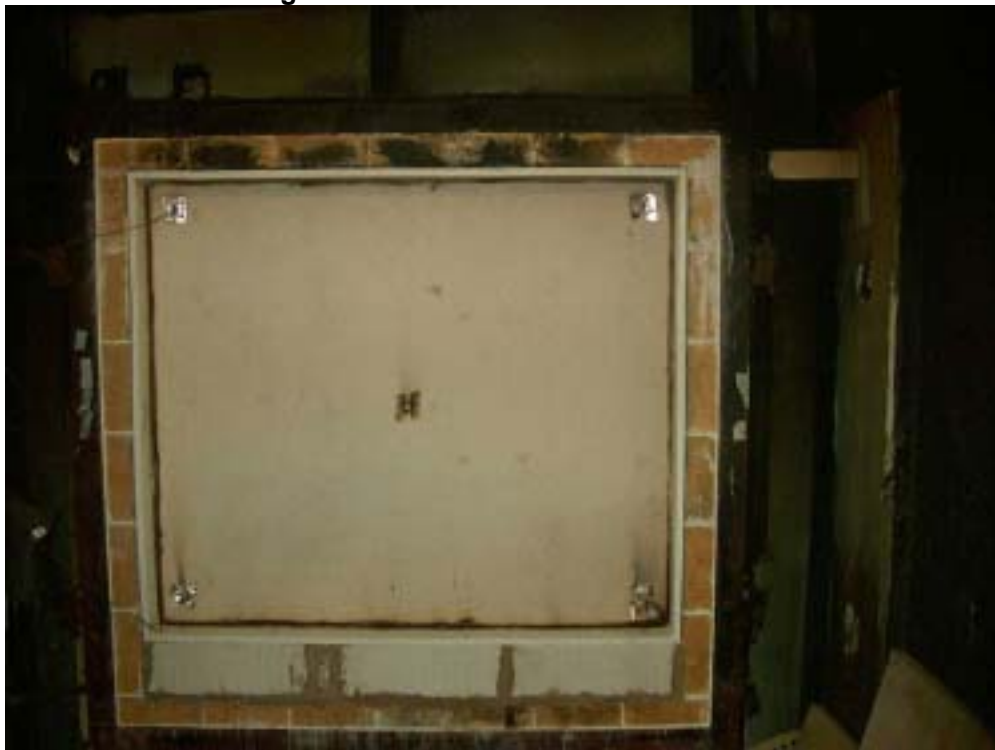
Figure 7 – Observation at 120 Minutes

- After 116 minutes, the exposed panel face began to bow into the furnace with the maximum bow of circa 50 mm noted at the mid point of the specimen.
- The calcium silicate board bead at position A-B (see Observation sheet in APPENDIX for reference), developed a crack after a period of 120 minutes.

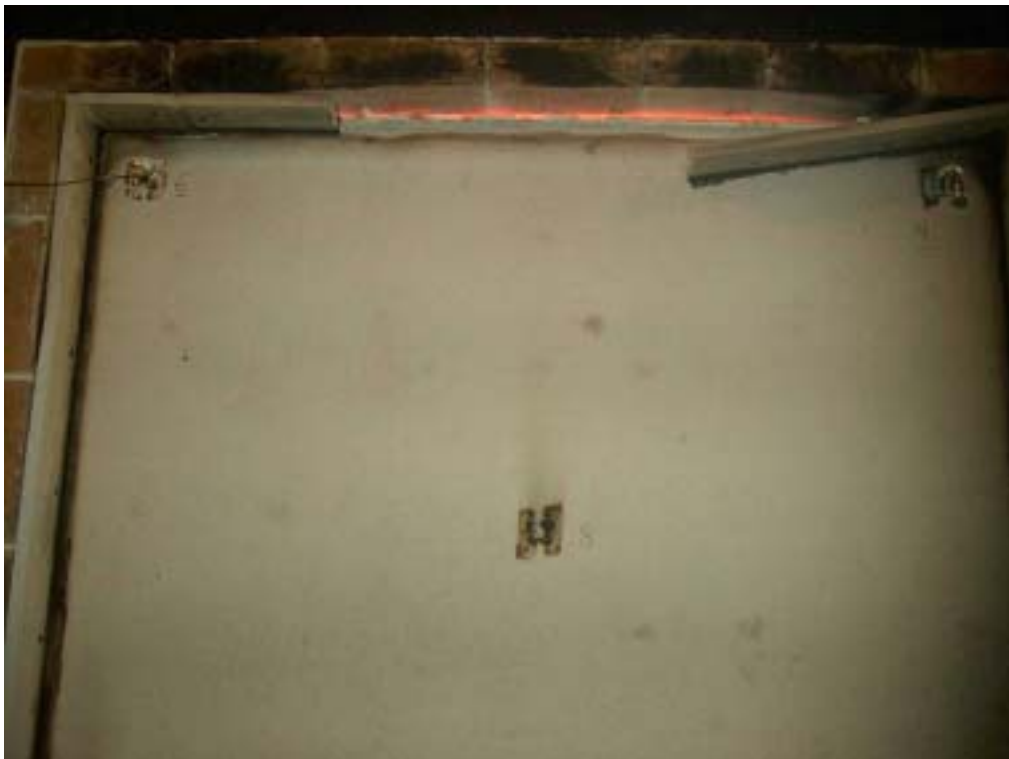
Figure 9 – Observation at 155 Minutes

- A section of the said bead became detached from the test frame surround after a period of 152 minutes to reveal a fissure between the frame surround and the 12 mm thick Versafire Fire Retardant Construction Board. At this point of proceedings, the system failed the cotton pad integrity test. It was noted that the 12 mm thick Versafire Fire Retardant Construction Board displayed no signs of integrity damage.

TIME (min;sec)	FACE (U/E) *	PRESSURE (Pa)	OBSERVATION DETAILS MADE BY TEST OPERATOR
155	U	7.6-9.3	Figure 9 – test continued
173	U	8.1-8.9	No change to condition noted at 154 minutes.
180	U	8.1-8.9	As above, test terminated Figure 10.
POST TEST OBSERVATIONS			
The maximum bow at the specimen centre was 65 mm, no surface cracks observed on the unexposed face. The exposed face showed a vertical open crack and a blistered surface (observations seen during early test stage). Figure 11 to 14 show post test illustrations.

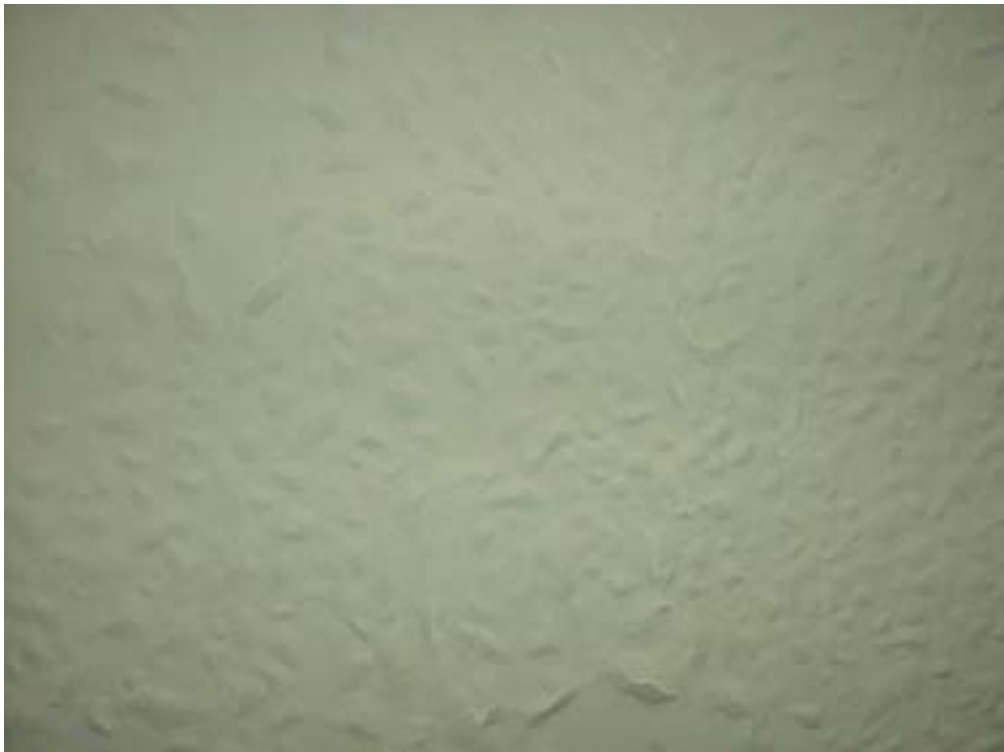
Figure 12 – Post Test Observation Fire Side Magnified

- After 13 minutes, the exposed face of the panel showed evidence of random surface cracks combined with a flaky appearance. After initial discolouration, this appearance was maintained throughout the test duration and is shown on the post test photograph Figure 12 in the APPENDIX.
